RE: Powder Springs Road Plating
Austell, Cobb County, Georgia
Preliminary Assessment Report

**PRELIMINARY ASSESSMENT
POWDER SPRINGS ROAD PLATING
AUSTELL, COBB COUNTY, GEORGIA**

June 2019

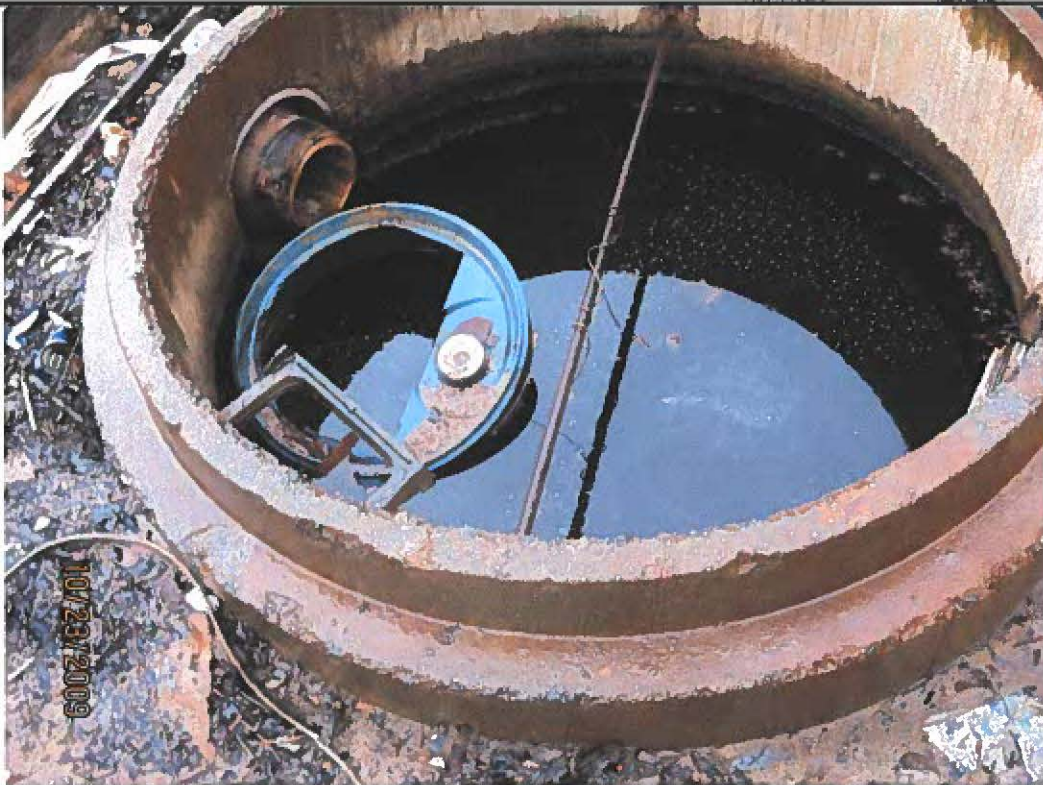
Facility Name: HW Enterprise Inc./Peach Chrome Plating	Location: Austell
Photo #: 29	Photographer: R. Hardy
Date: 10/23/2009	
Explanation: Pre-treatment area settling tank.

The Pre-Treatment area was located outside the building through an open rollup door on the east building wall. The Pre-Treatment area had a round settling tank and a rectangular mixing tank, both sunken into a concrete pad, and both with dark brown liquid inside (Photos 29 and 30). Dark brown liquid was also observed inside the effluent discharge port to the county sewer system (Photo 40). Two full ~55 gallon containers were up on stands adjacent to the Pre-Treatment Tanks (Photo 31). One of the containers was labeled lush water (presumably flush water) holding tank. Also in the Pre-Treatment area were: one 15 gallon container of Sulfuric Acid; one 15 gallon container of copper cyanide; three 55 gallon containers of sulfuric acid; one 5 gallon container of "Reflecta Maintenance Nickel Plating Agent"; and one 275 gallon tote with brown liquid inside (Photos 32-39).

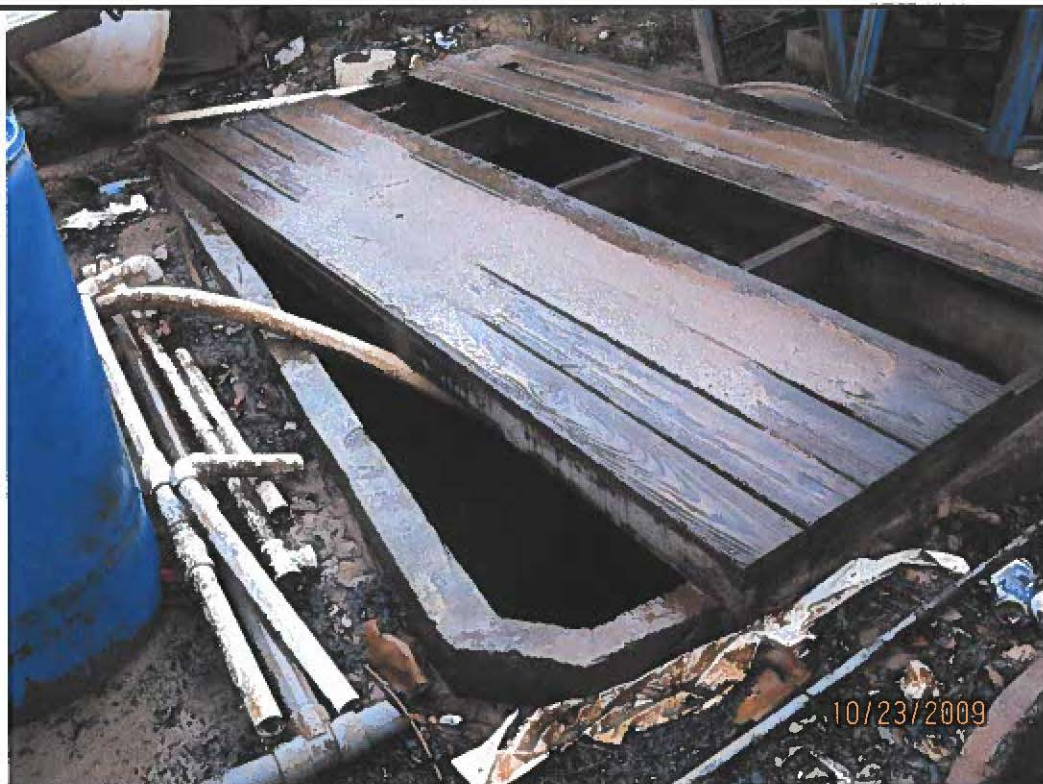
Facility Name: HW Enterprise Inc./Peach Chrome Plating	Location: Austell
Photo #: 30	Photographer: R. Hardy
Date: 10/23/2009	
Explanation: Pre treatment area mixing tank.

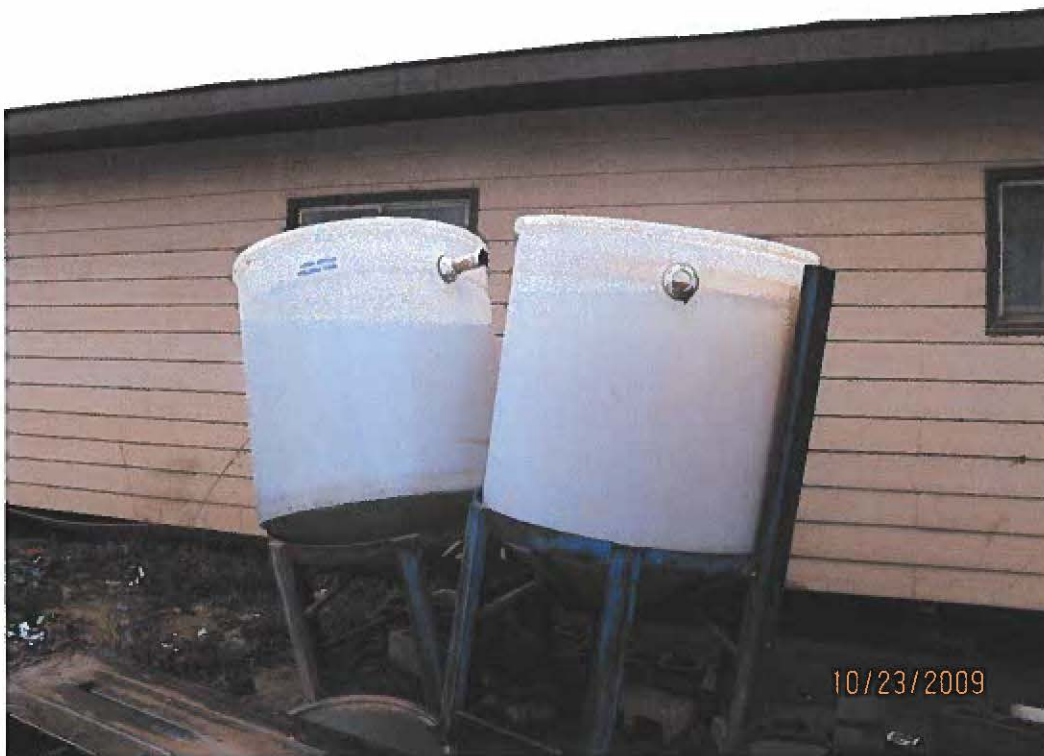
Facility Name: HW Enterprise Inc./Peach Chrome Plating	Location: Austell
Photo #: 31	Photographer: R. Hardy
Date: 10/23/2009	
Explanation: Pre treatment area. Full containers on stands. Flush Water holding tanks.

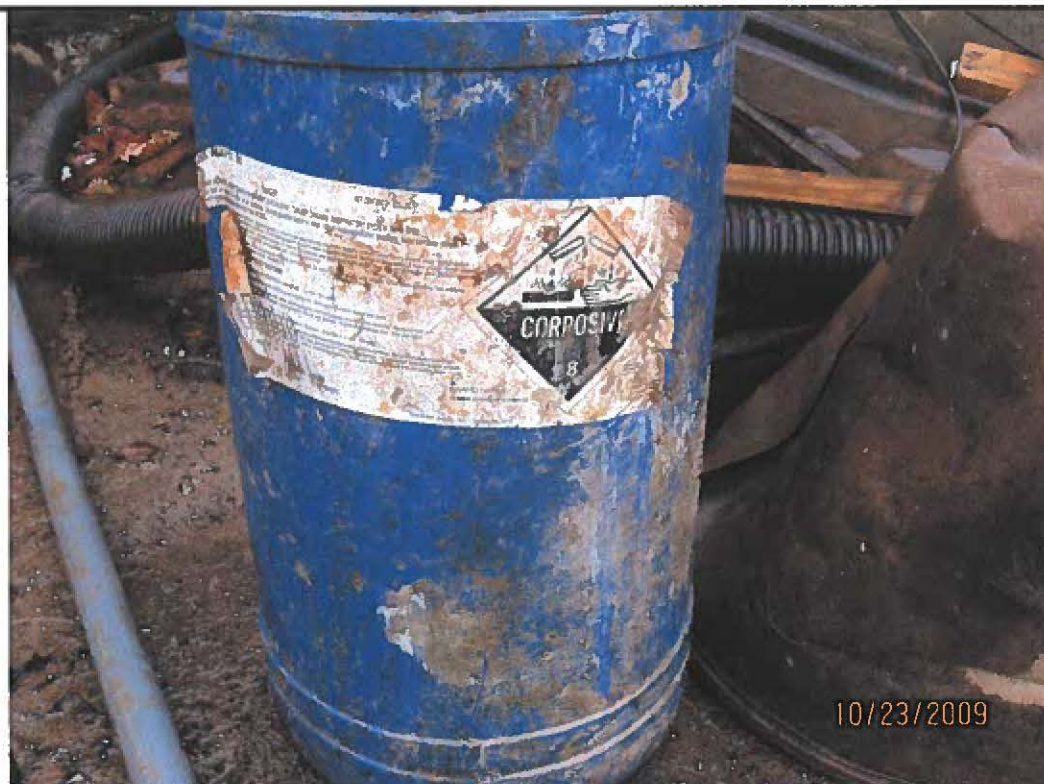
Facility Name: HW Enterprise Inc./Peach Chrome Plating	Location: Austell
Photo #: 32	Photographer: R. Hardy
Date: 10/23/2009	
Explanation: Pre treatment Area. 15 gallon container of Sulfuric Acid.

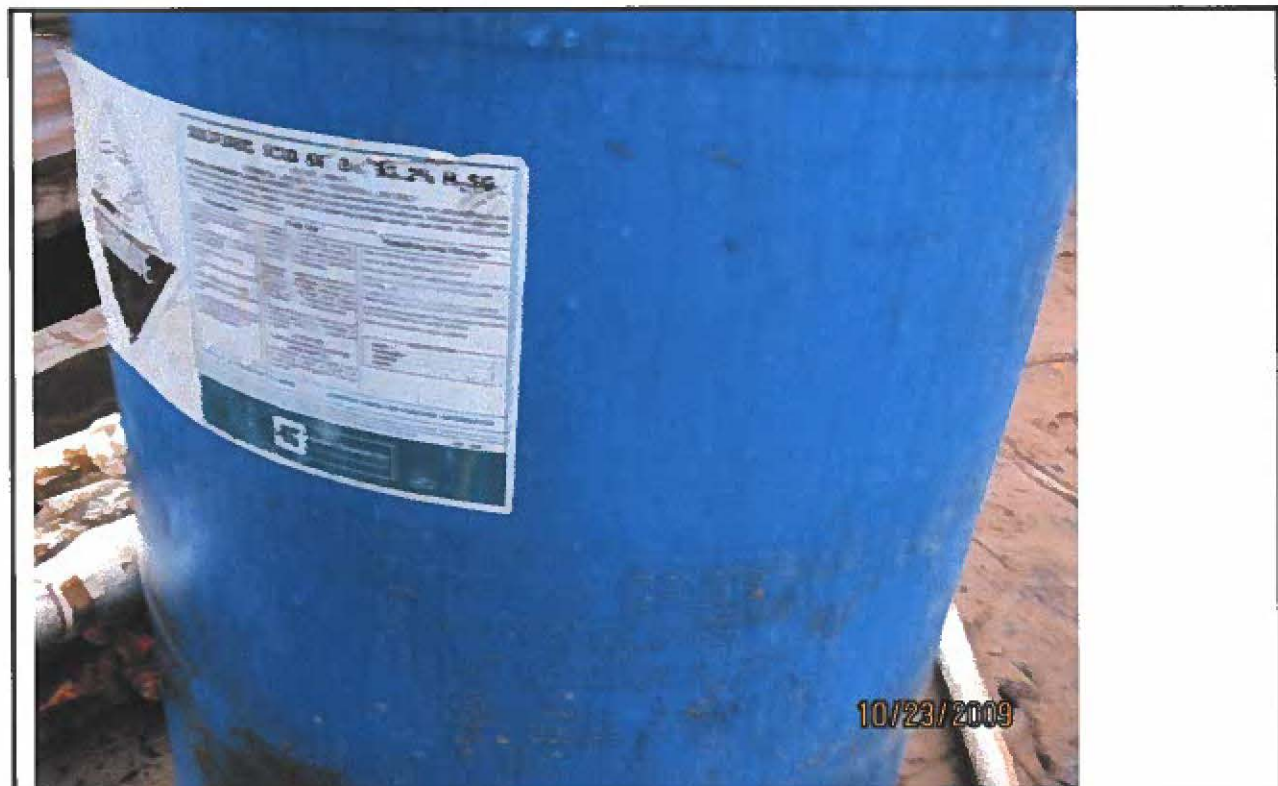
Explanation: Pre treatment area. 55 gallon container of sulfuric acid.

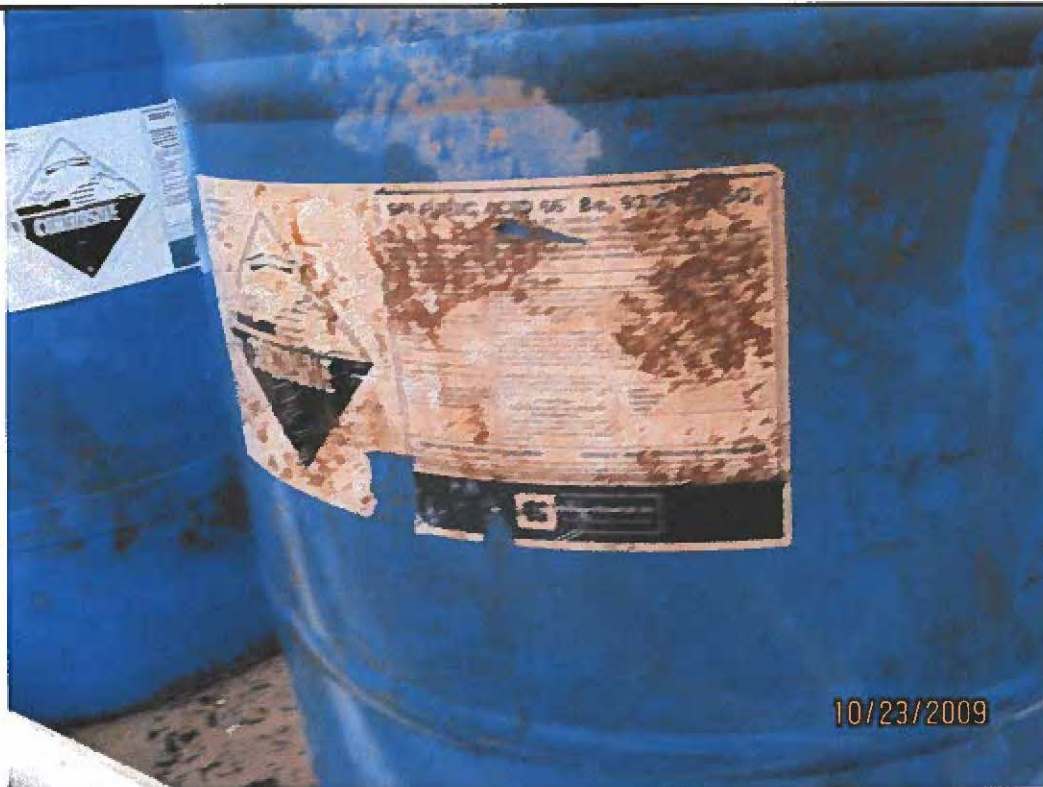
Facility Name: HW Enterprise Inc./Peach Chrome Plating	Location: Austell
Photo #: 35	Photographer: R. Hardy
Date: 10/23/2009	
Explanation: Pre treatment area. 55 gallon container of sulfuric acid.

- Two full 55-gallon containers, one unlabeled, one labeled “Lush Water” were observed on stands adjacent to the pre-treatment/wastewater treatment tanks. One 15-gallon container of sulfuric acid, one 15-gallon container of copper cyanide, three 55-gallon containers of sulfuric acid, one container of unknown volume labeled “Reflecta Maintenance Nickel” and one 275-gallon tote containing brown liquid was also observed in the pre-treatment/wastewater treatment system area. The volume of liquid in each container was unknown.

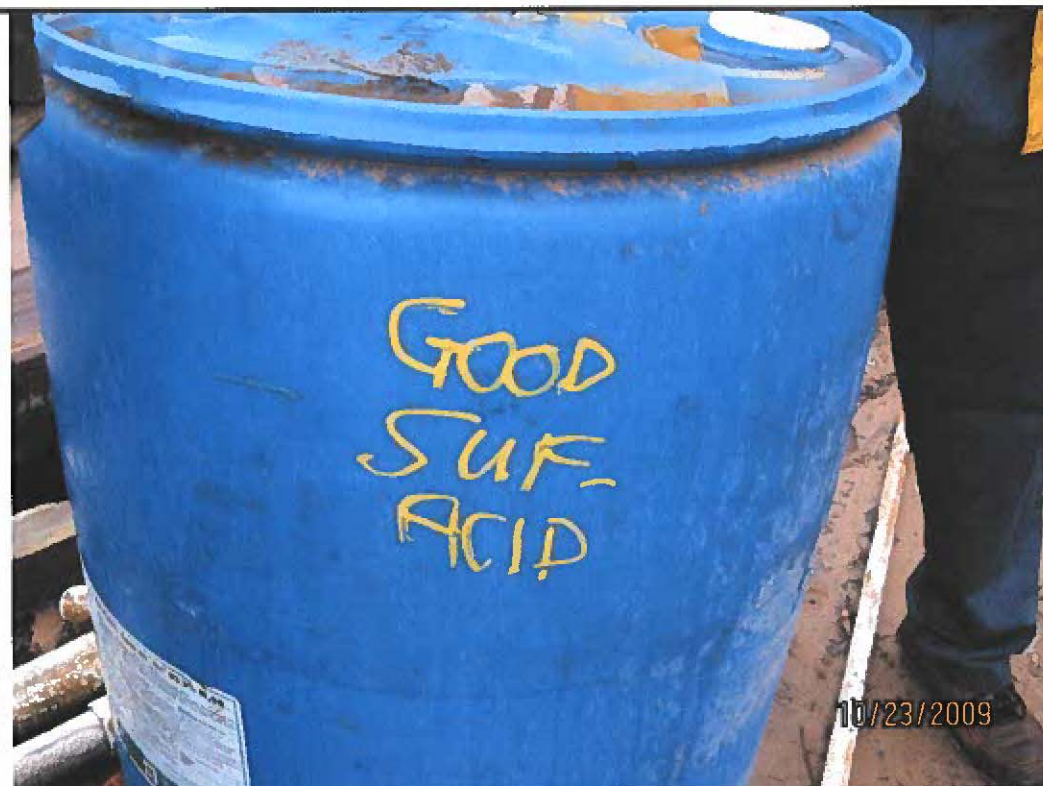
Facility Name: HW Enterprise Inc./Peach Chrome Plating	Location: Austell
Photo #: 36	Photographer: R. Hardy
Date: 10/23/2009	
Explanation: Pre treatment area. 55 gallon container of "good" sulfuric acid.

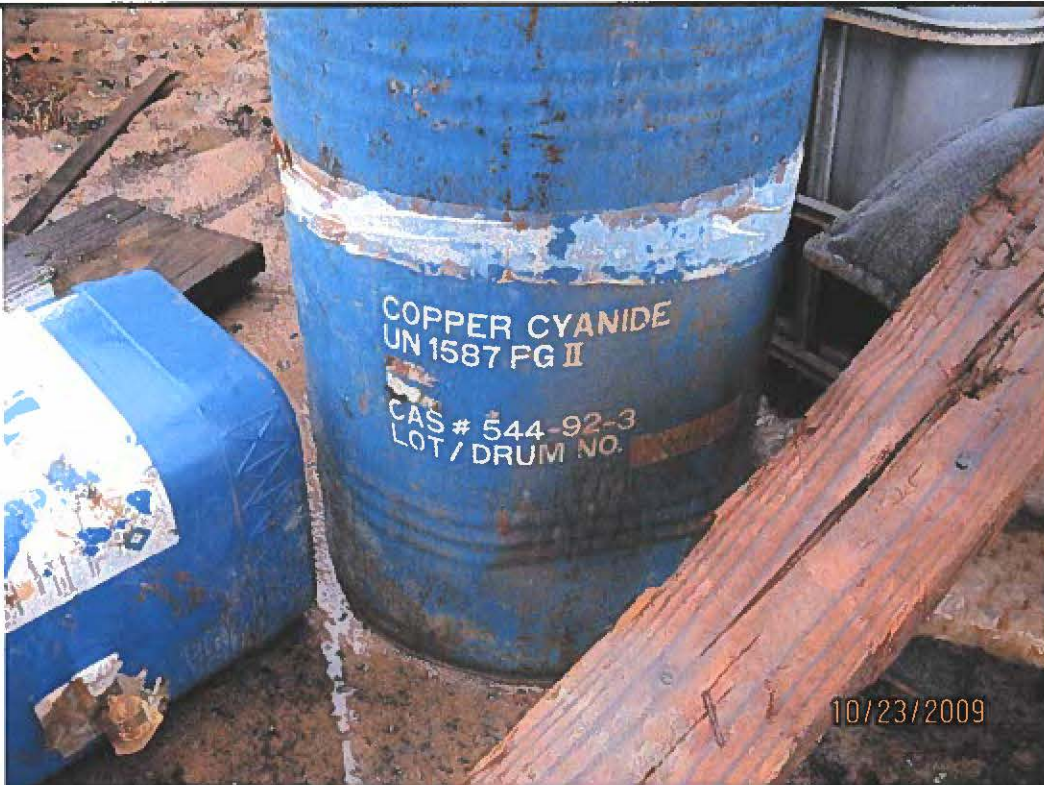
Facility Name: HW Enterprise Inc./Peach Chrome Plating	Location: Austell
Photo #: 37	Photographer: R. Hardy
Date: 10/23/2009	
Explanation: Pre treatment Area. 15 gallon container Copper Cyanide

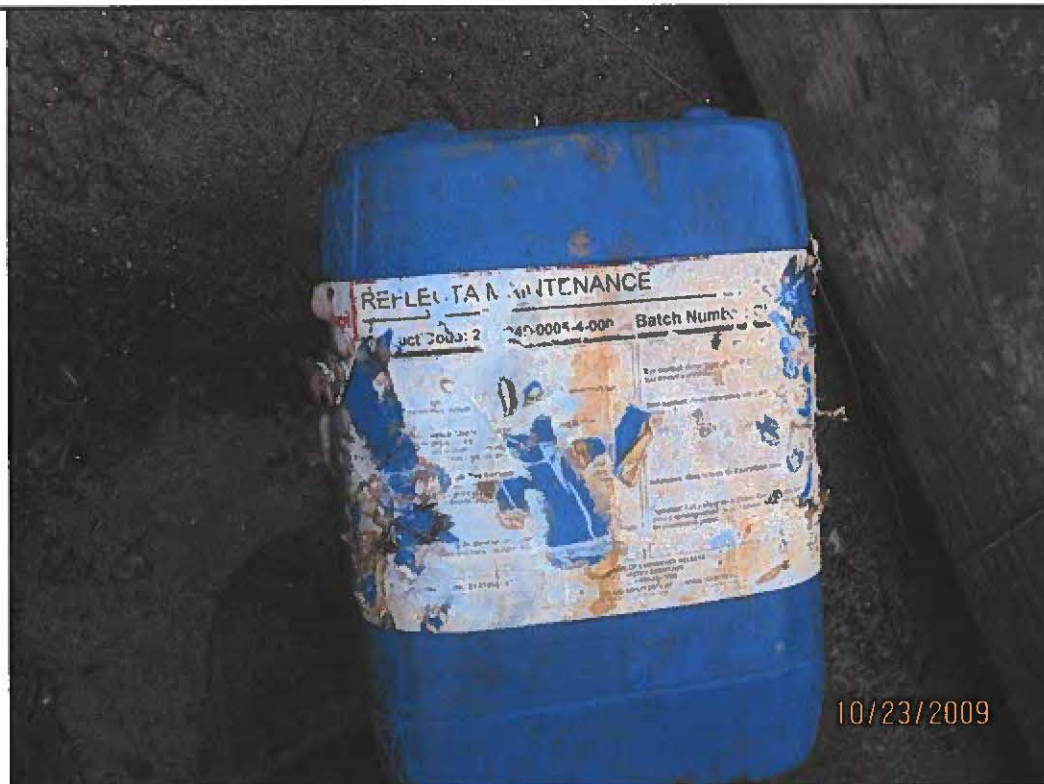
Facility Name: HW Enterprise Inc./Peach Chrome Plating	Location: Austell
Photo #: 38	Photographer: R. Hardy
Date: 10/23/2009	
Explanation: Pre Treatment Area. Reflecta Maintenance Nickel Plating Agent.

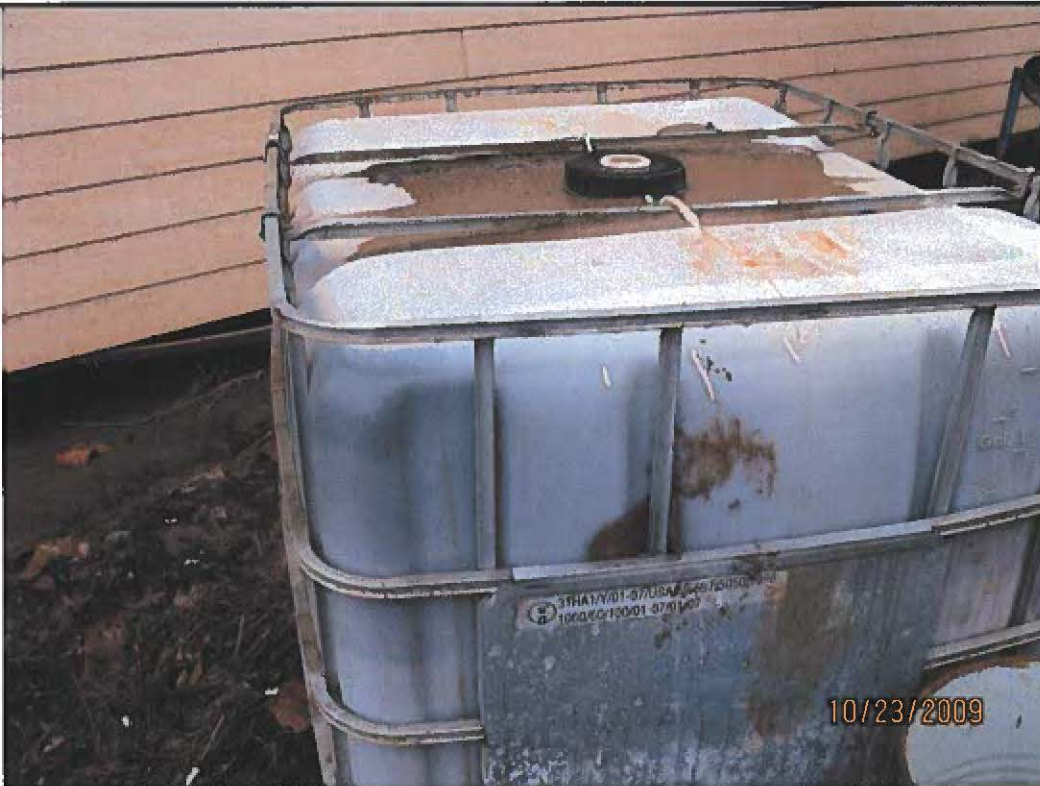
Facility Name: HW Enterprise Inc./Peach Chrome Plating	Location: Austell
Photo #: 39	Photographer: R. Hardy
Date: 10/23/2009	
Explanation: Pre treatment area. Full 275 gallon tote

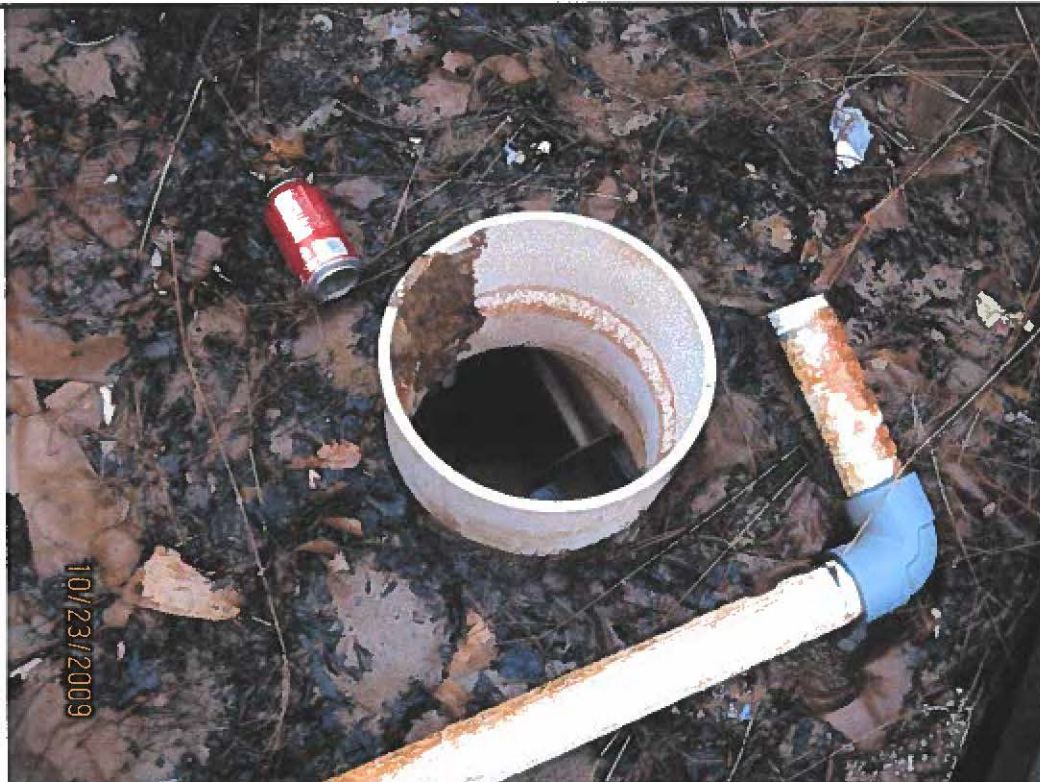
Facility Name: HW Enterprise Inc./Peach Chrome Plating	Location: Austell
Photo #: 40	Photographer: R. Hardy
Date: 10/23/2009	
Explanation: Effluent discharge port to county sewer system.

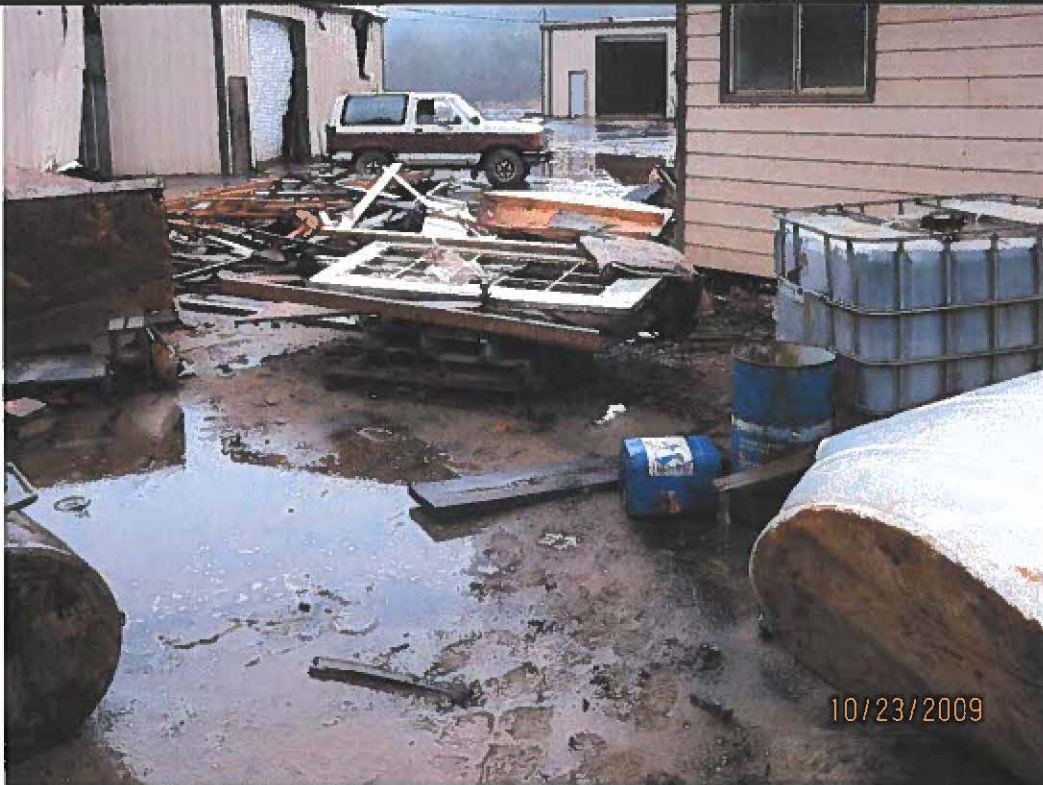
Facility Name: HW Enterprise Inc./Peach Chrome Plating	Location: Austell
Photo #: 41	Photographer: R. Hardy
Date: 10/23/2009	
Explanation: Pre-treatment area. Note full 275 gallon tote, photo right.

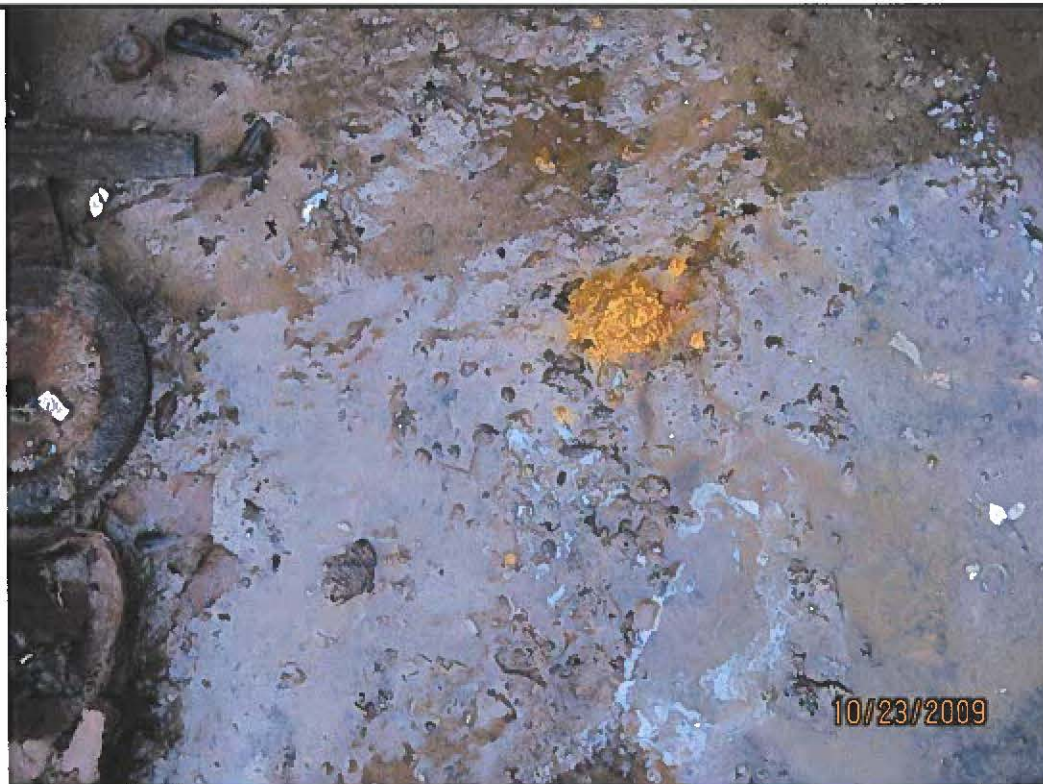
Facility Name: HW Enterprise Inc./Peach Chrome Plating	Location: Austell
Photo #: 42	Photographer: R. Hardy
Date: 10/23/2009	
Explanation: Small pile of ocher colored material out side of building.

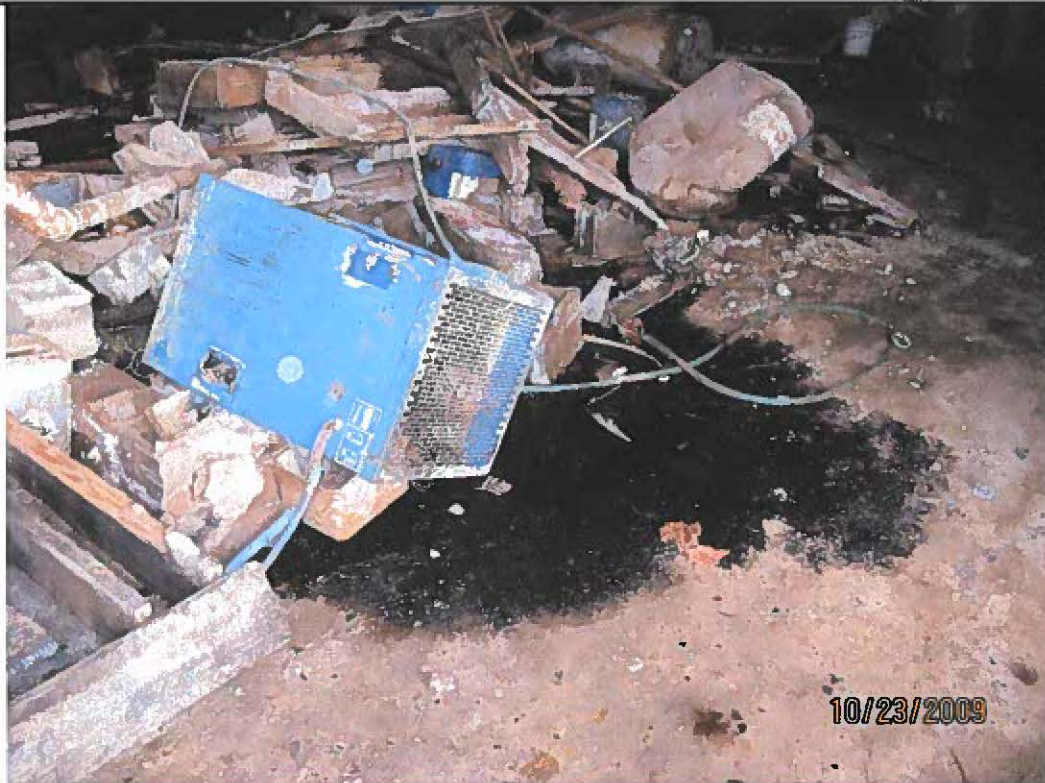
Facility Name: HW Enterprise Inc./Peach Chrome Plating	Location: Austell
Photo #: 43	Photographer: R. Hardy
Date: 10/23/2009	
Explanation: Dark liquid under debris inside building. Note electric welder.

The building was strewn with debris from the flood damage, numerous full and empty (spilled) containers of various sizes, and puddles of dark brown to black liquid and sludge mixed with soil (Photos 20, 22-25, 43, 44, 49-52). There were approximately 16 upright, unlabeled 55 gallon containers that appeared to be full of plating waste sludge around the plating tank. (Photos 19 and 20) There were six more upright 55 gallon containers that were staged in the northwest corner of the building (photo 49, in the far distance). The labels on these containers were damaged or not visible due to the way the containers were staged. One label was legible and read "Caustic Soda Anhydrous" (Sodium Hydroxide) (Photo 21). One 55 gallon container was observed laying on it's side, open, with metallic material spilling out (Photo 27). A few other unclearly labeled 55 gallon containers were scattered throughout the building. (Photos 15, 28, 50) Numerous 5 gallon containers of plating bath

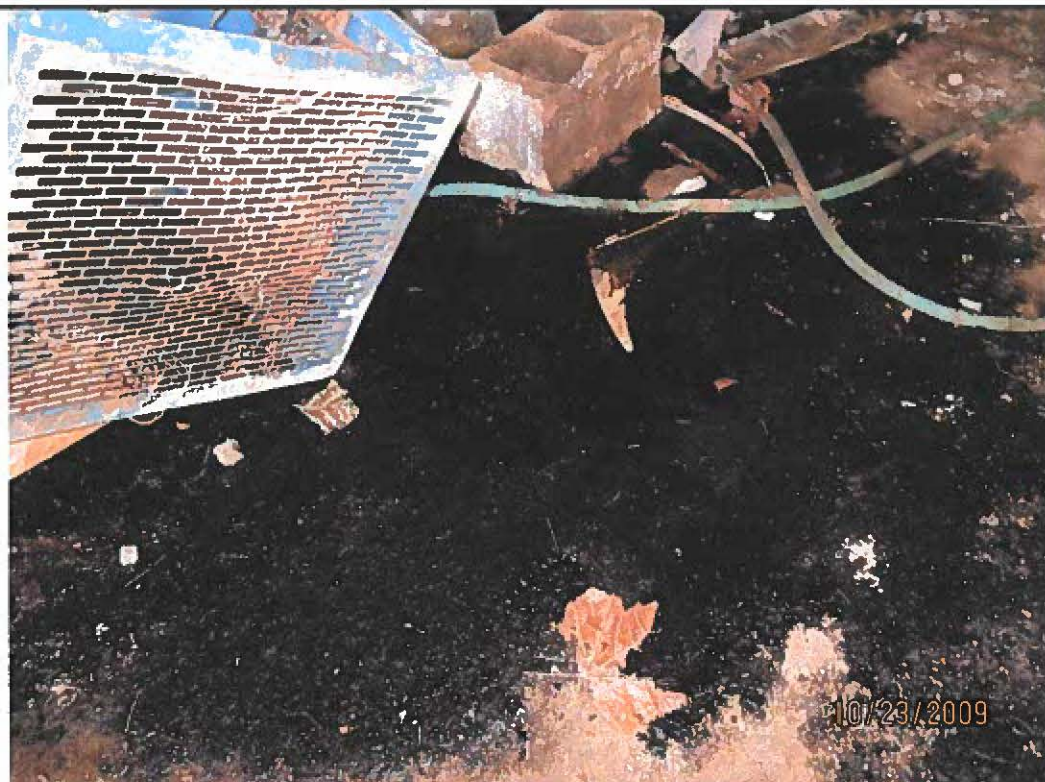
Facility Name: HW Enterprise Inc./Peach Chrome Plating	Location: Austell
Photo #: 44	Photographer: R. Hardy
Date: 10/23/2009	
Explanation: Dark liquid under debris inside building.

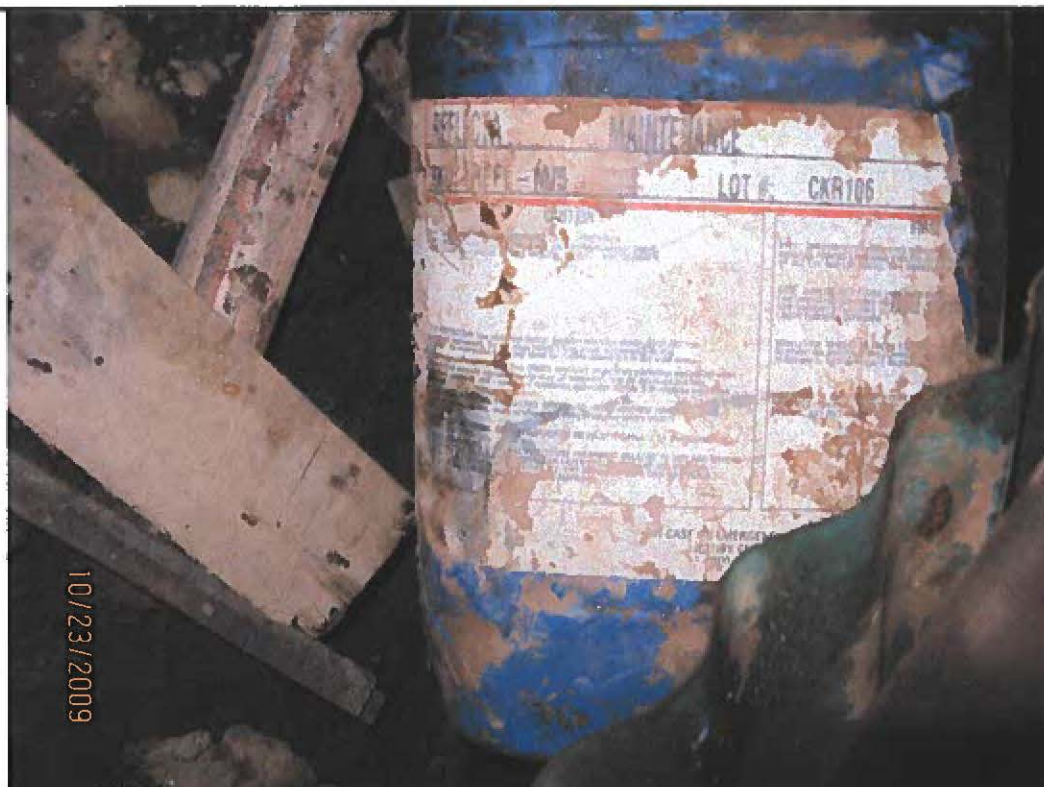
Facility Name: HW Enterprise Inc./Peach Chrome Plating	Location: Austell
Photo #: 45	Photographer: R. Hardy
Date: 10/23/2009	
Explanation: Reflecta Maintenance Nickel Plating Agent inside building.

additives were scattered throughout the building. Among those with legible labels included: "Cupra Brite 432 Replenisher (2)"; "DIS-MIST" (2); "Reflecta Maintenance-Nickel Plating Agent" (2). (Photos 25, 26, 45, and 46. Outside a tear in the north building wall, pushed through the wall by flood waters, were two 5 gallon containers of Nickel sulfate liquid (Photos 47,48). Two unlabeled 275 gallon totes full of brown liquid were also observed inside the building (Photo 50).

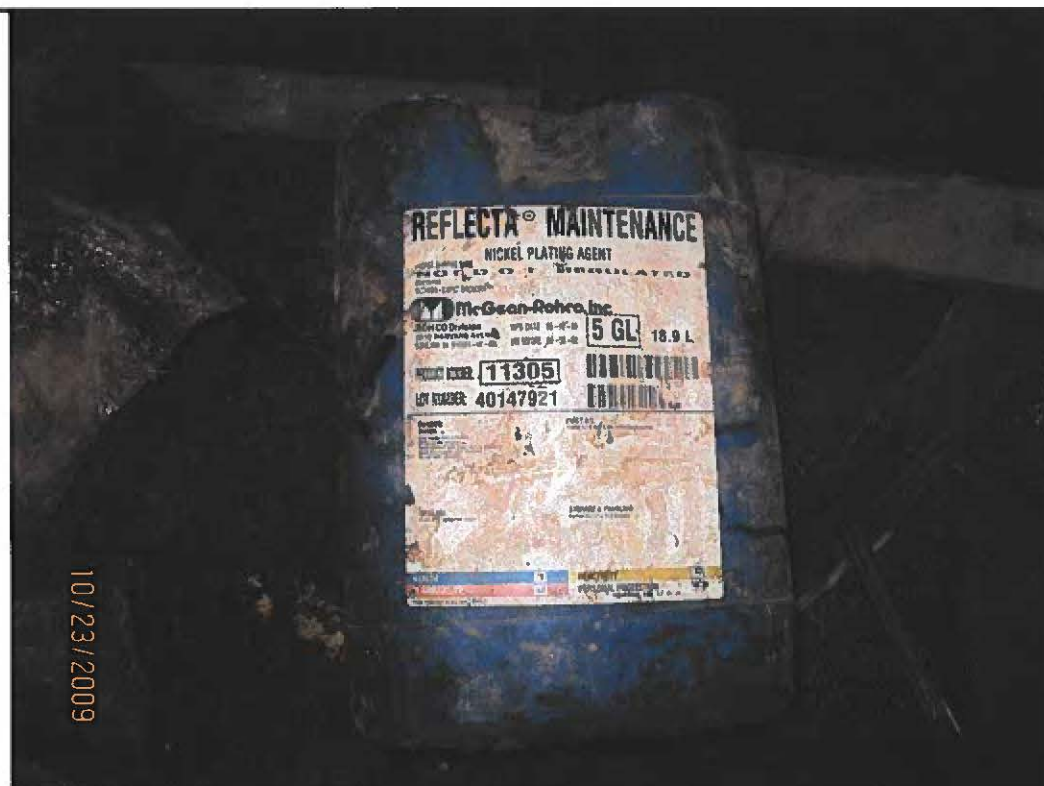
Facility Name: HW Enterprise Inc./Peach Chrome Plating	Location: Austell
Photo #: 46	Photographer: R. Hardy
Date: 10/23/2009	
Explanation: Reflecta Maintenance Nickel Plating Agent inside building.

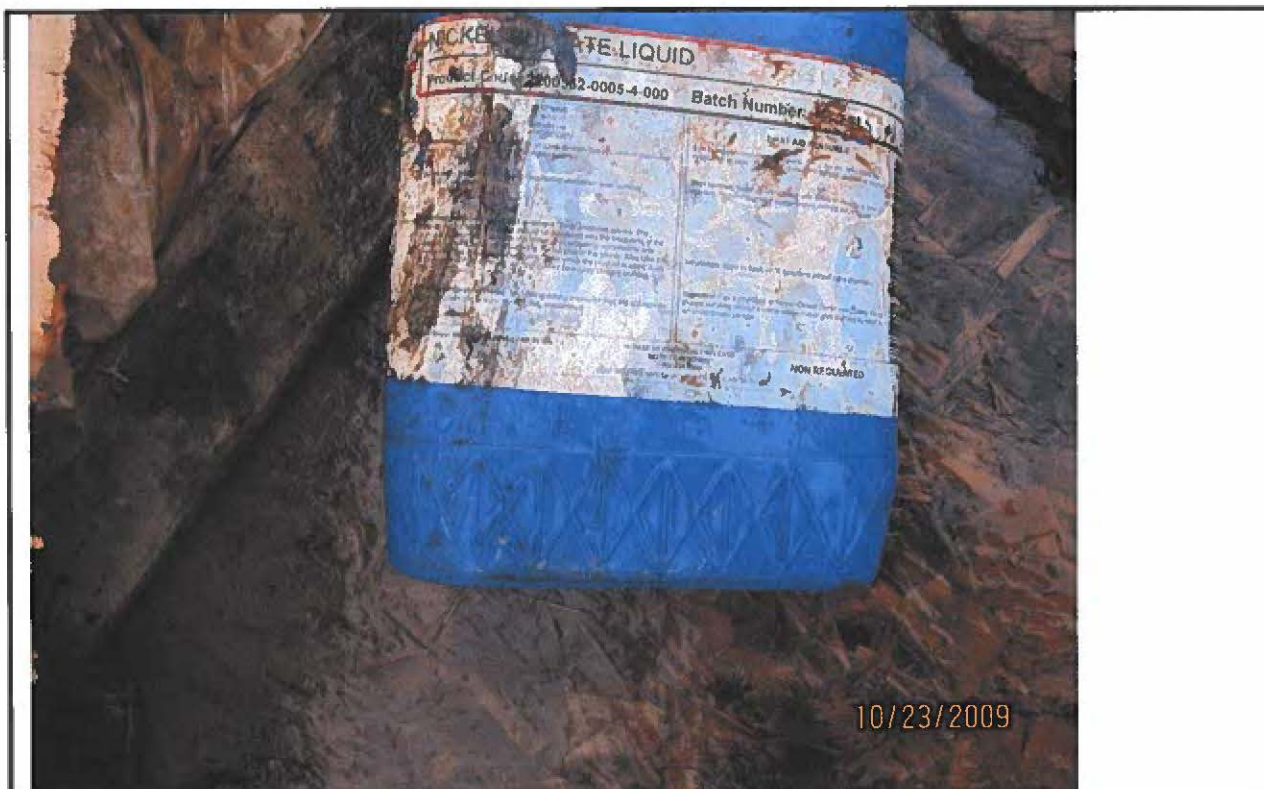
Photo #: 47 **Photographer:** R. Hardy **Date:** 10/23/2009

Explanation: Nickel Sulfate Liquid. Pushed through North building wall.

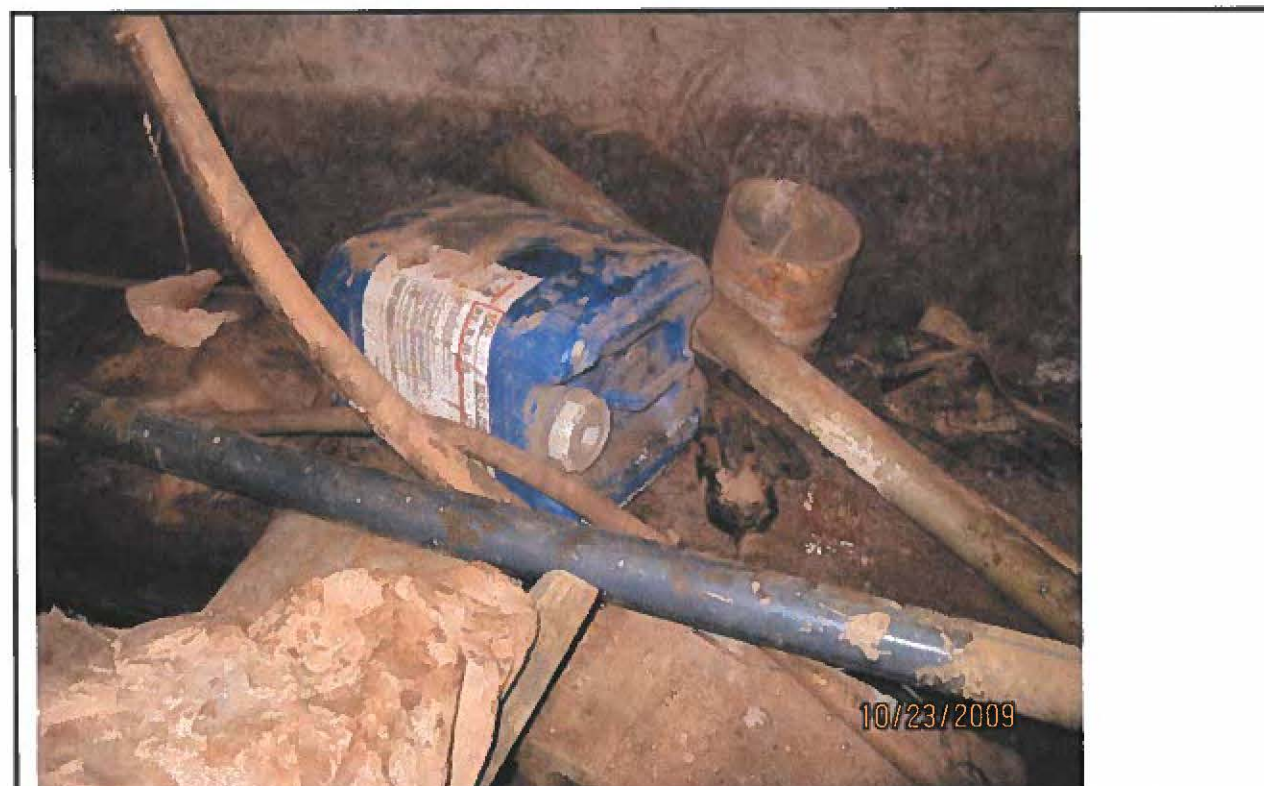
Photo #: 48 **Photographer:** R. Hardy **Date:** 10/23/2009

Explanation: Nickel Sulfate Liquid. Pushed through North building wall.

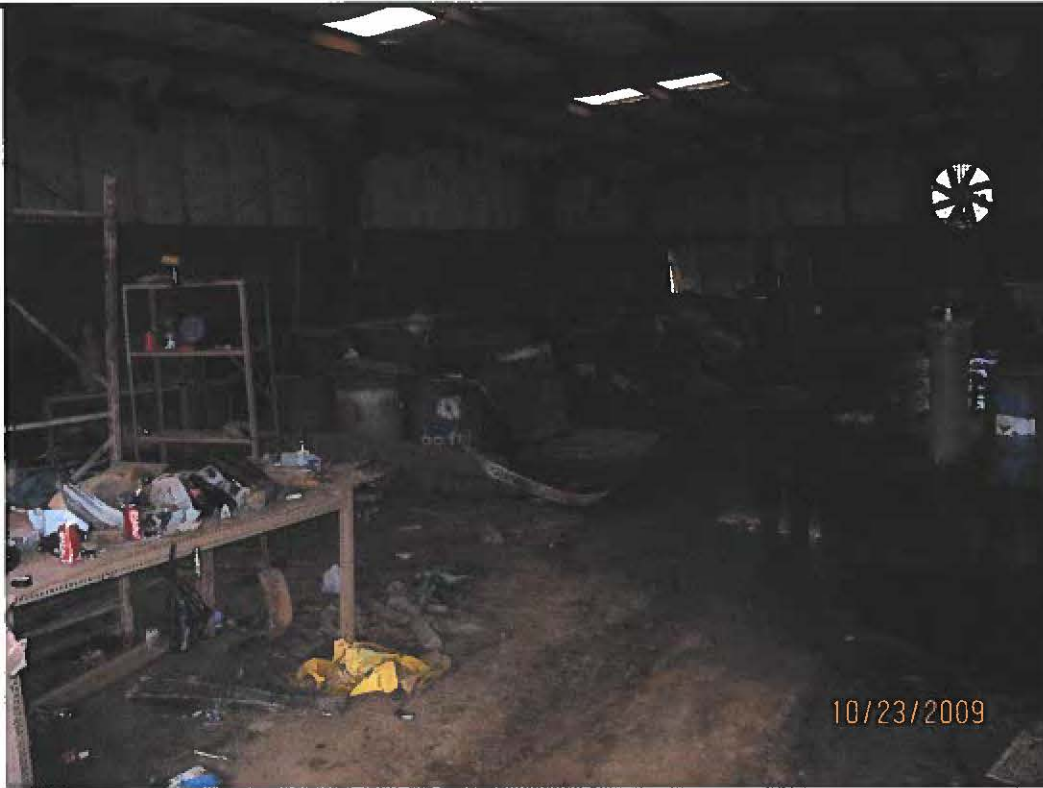
Photo #: 49	Photographer: R. Hardy	Date: 10/23/2009
--------------------	-------------------------------	-------------------------

Explanation: Panoramic sequence from entrance. Northwest look.

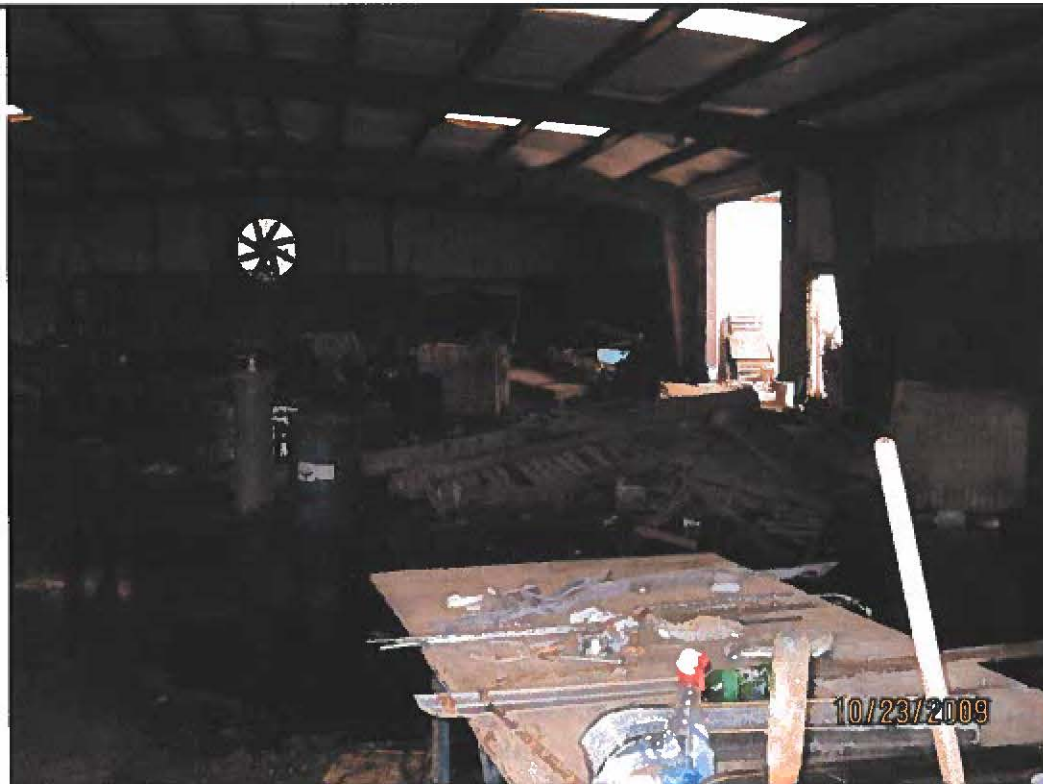
Photo #: 50	Photographer: R. Hardy	Date: 10/23/2009
--------------------	-------------------------------	-------------------------

Explanation: Panoramic sequence from entrance. North look. Note two 275 gallon totes.
--

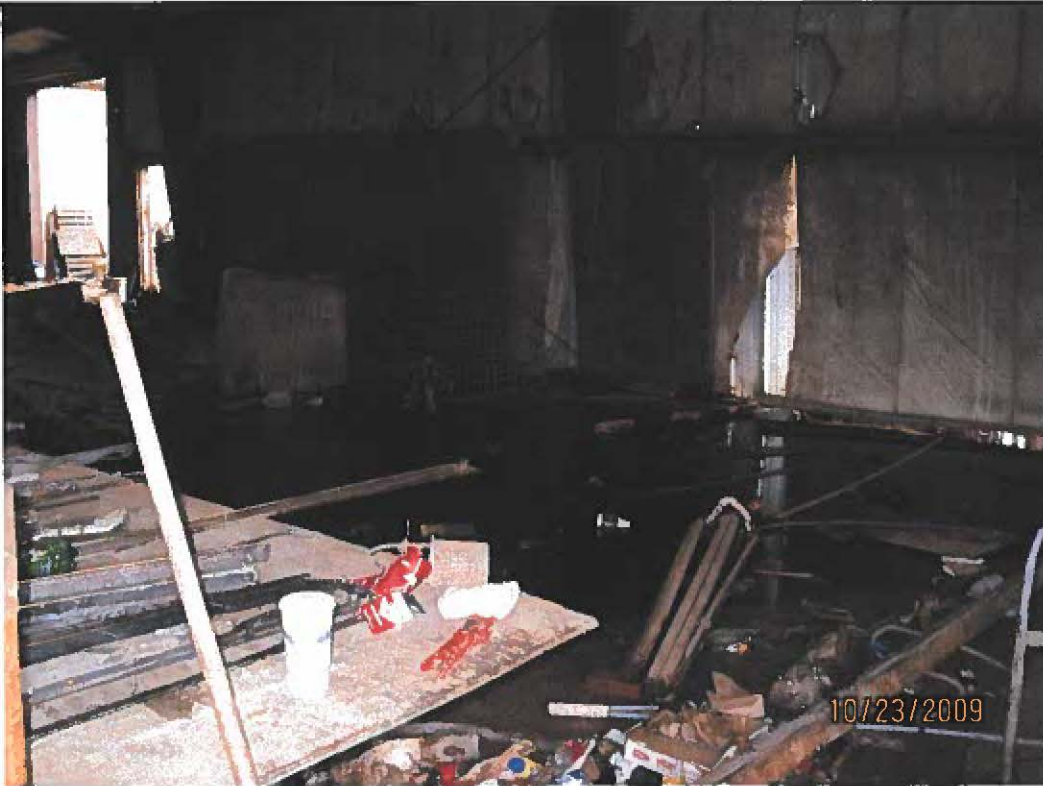
Photo #: 51	Photographer: R. Hardy	Date: 10/23/2009
--------------------	-------------------------------	-------------------------

Explanation: Panoramic sequence from entrance. Northeast look
--

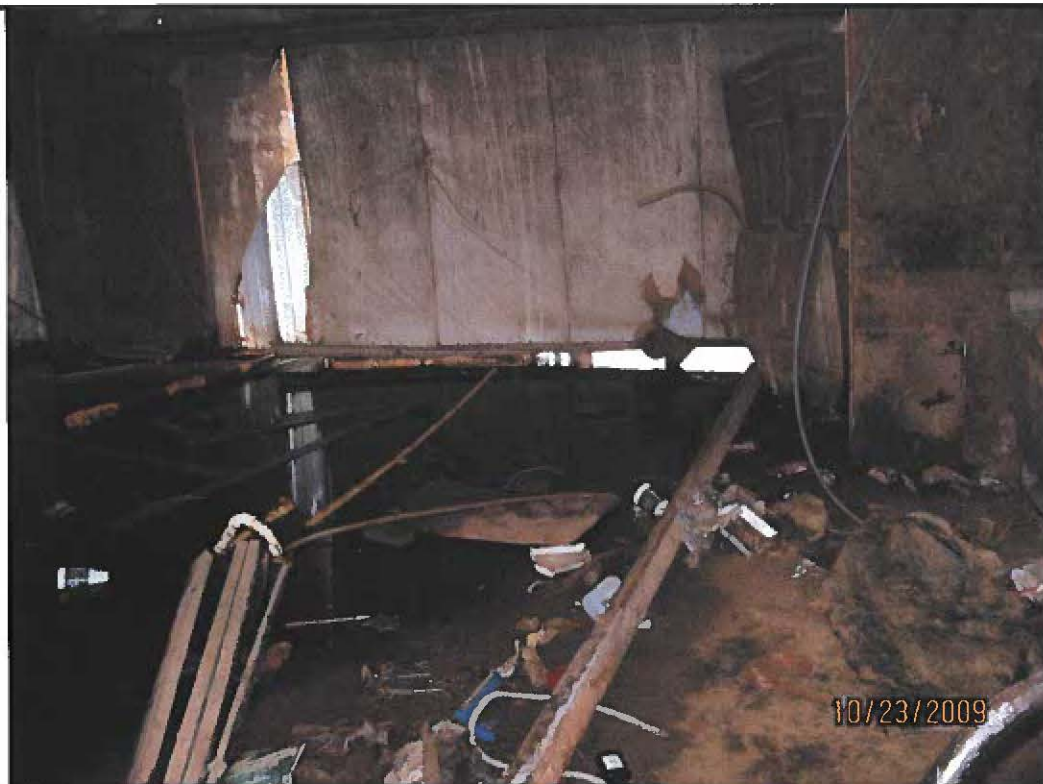
Photo #: 52	Photographer: R. Hardy	Date: 10/23/2009
--------------------	-------------------------------	-------------------------

Explanation: Panoramic sequence from entrance. East Northeast look. Note pool of liquid.

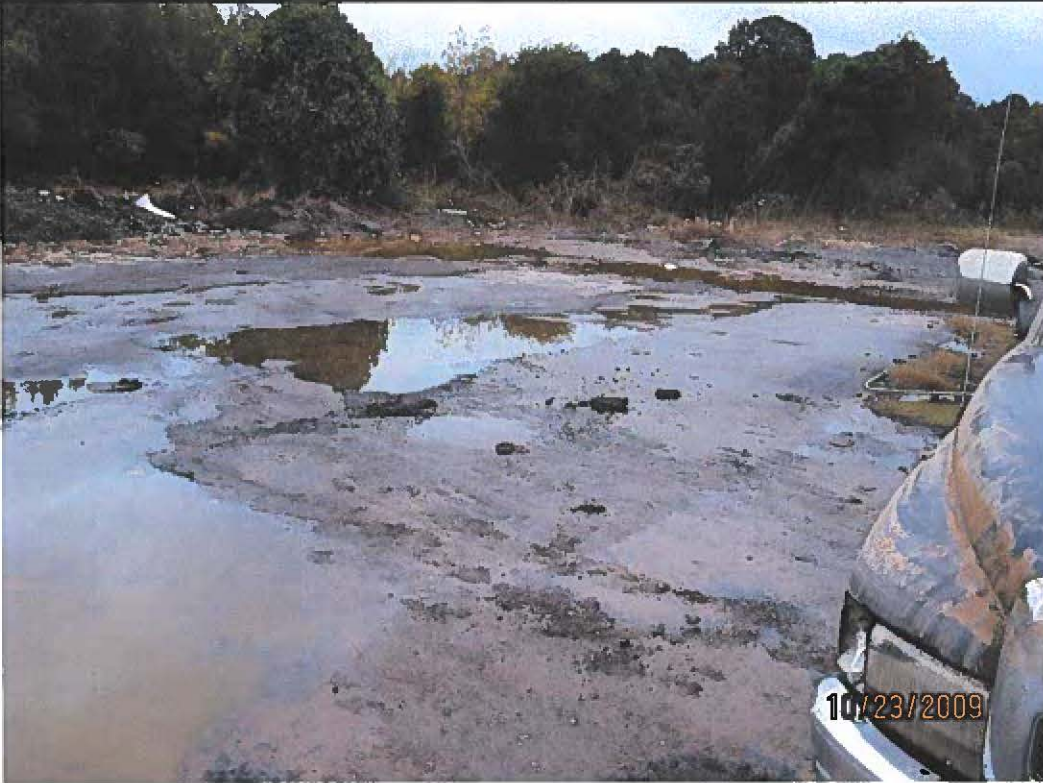
Facility Name: HW Enterprise Inc./Peach Plating	Location: Austell
Photo #: 53 Photographer: R. Hardy	Date: 10/23/2009
Explanation: End of asphalt apron, looking toward ephemeral tributary.

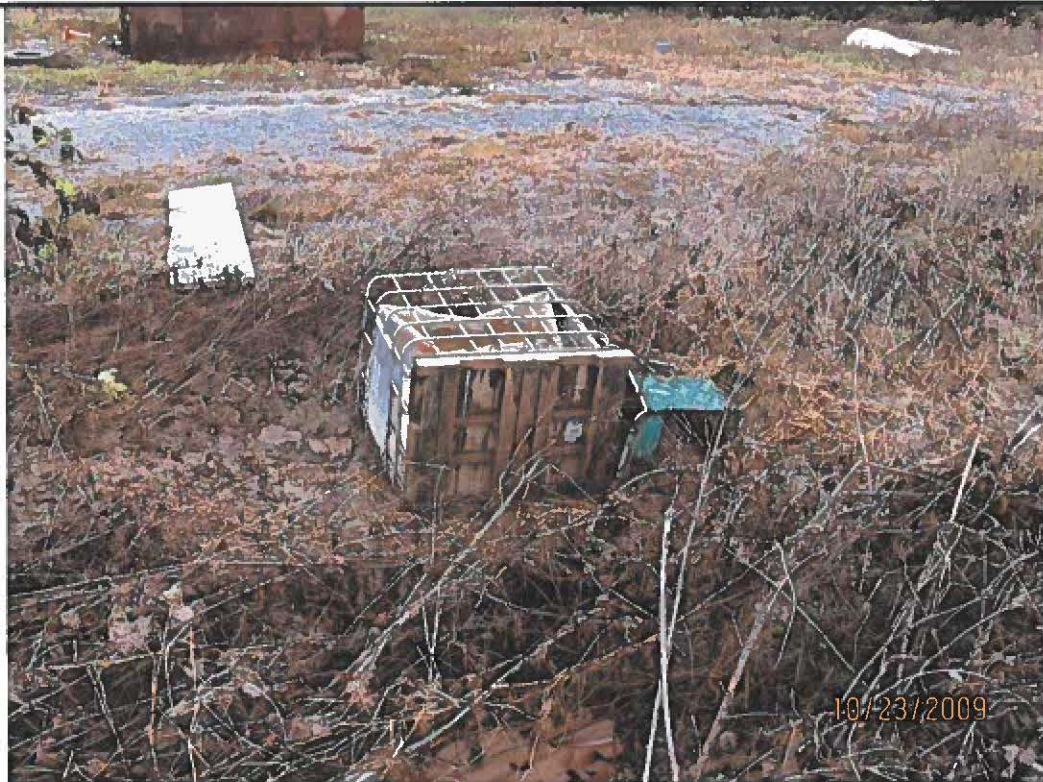
Facility Name: HW Enterprise Inc./Peach Plating	Location: Austell
Photo #: 54 Photographer: R. Hardy	Date: 10/23/2009
Explanation: Partially full 275 gallon tote in field between asphalt and ephemeral tributary
